**SUBJECT:** A Hispanic car wash supervisor died when an air tank exploded in a car wash equipment room.

**SUMMARY**  
**California FACE Report #05CA010**

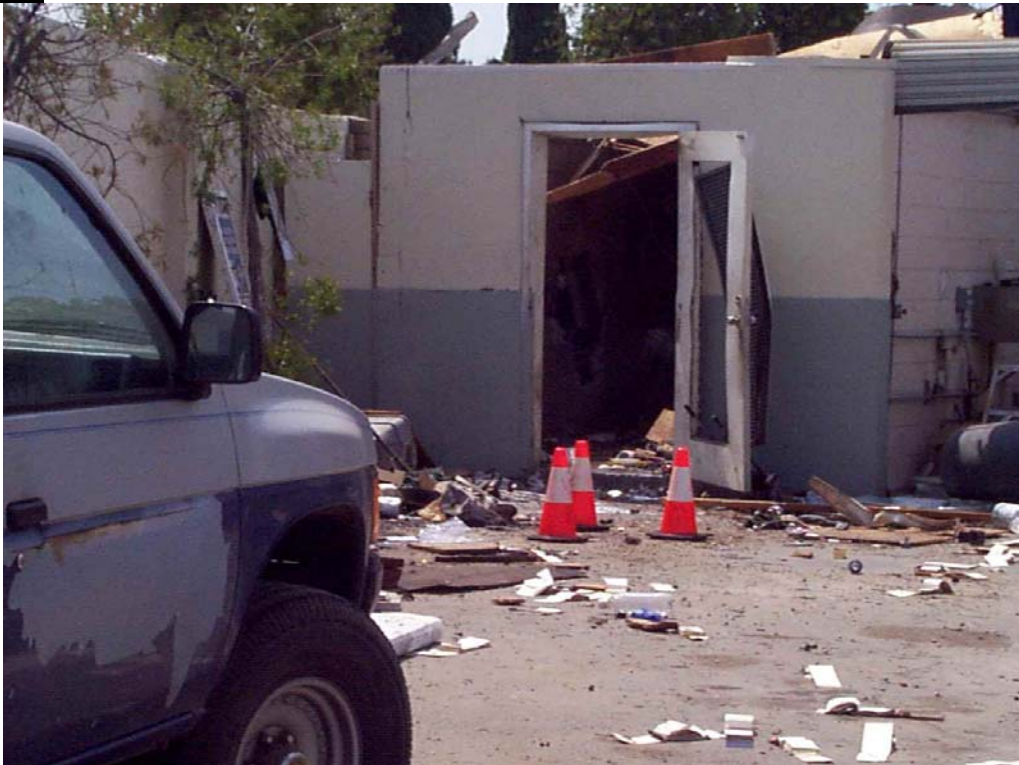
Exhibit 1. The equipment room after the explosion.

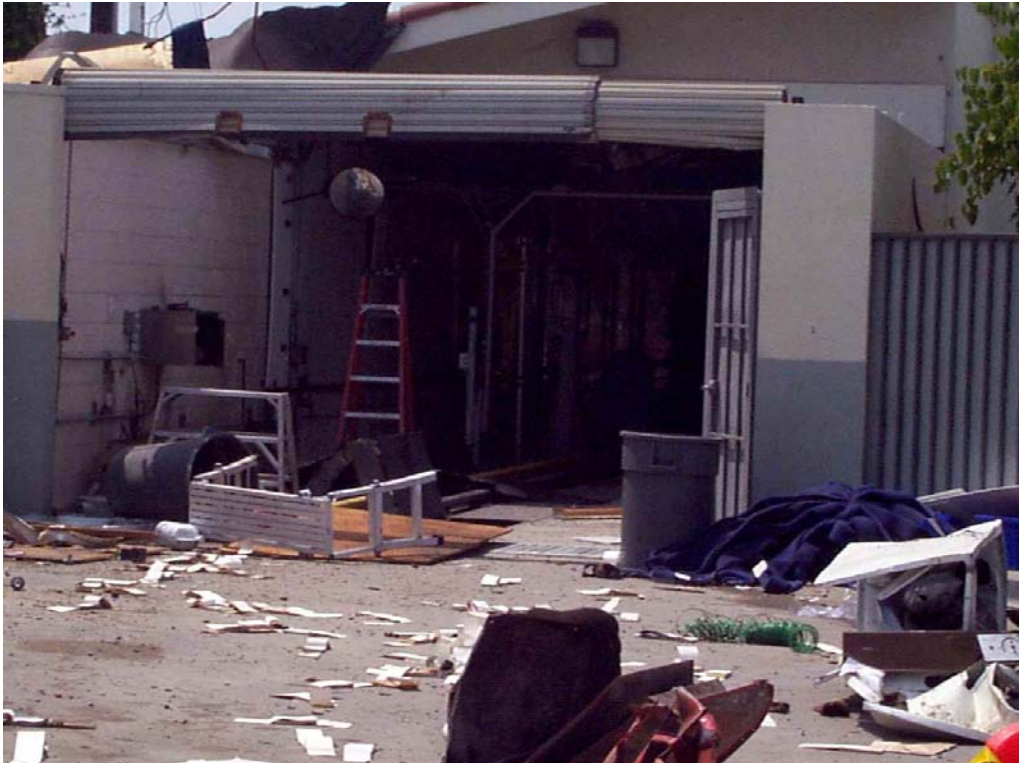
Exhibit 2. The car wash tunnel entrance after the explosion.

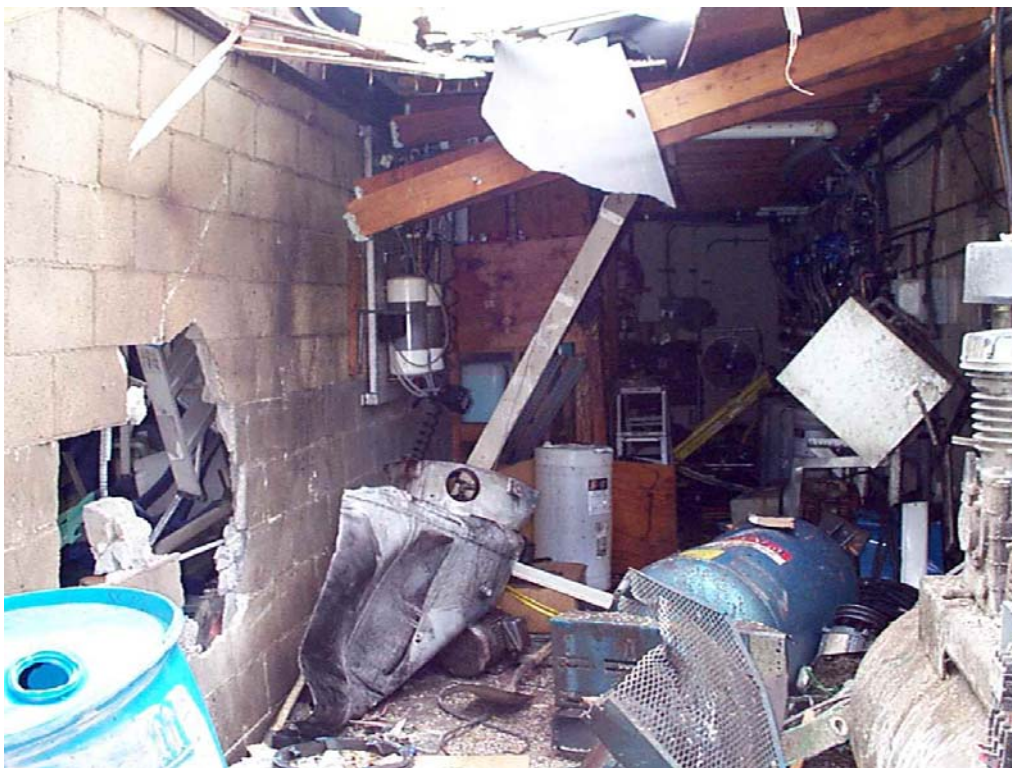
Exhibit 3. The inside of the equipment room after the explosion.

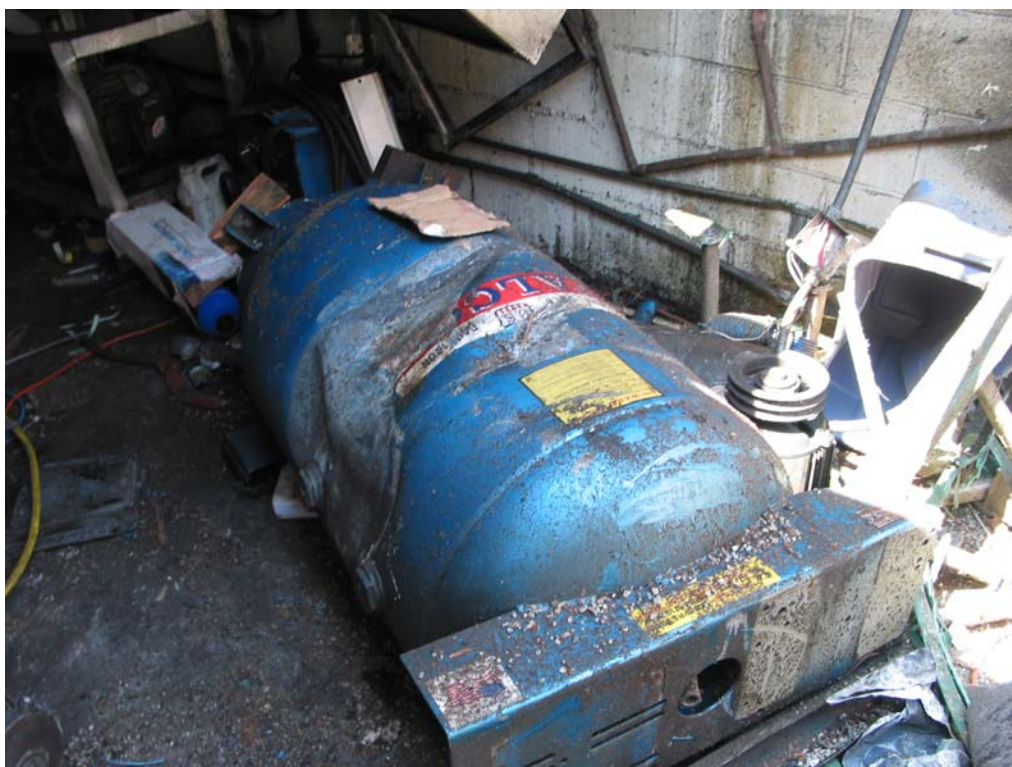
Exhibit 4. The second air tank inside the equipment room, which did not explode.

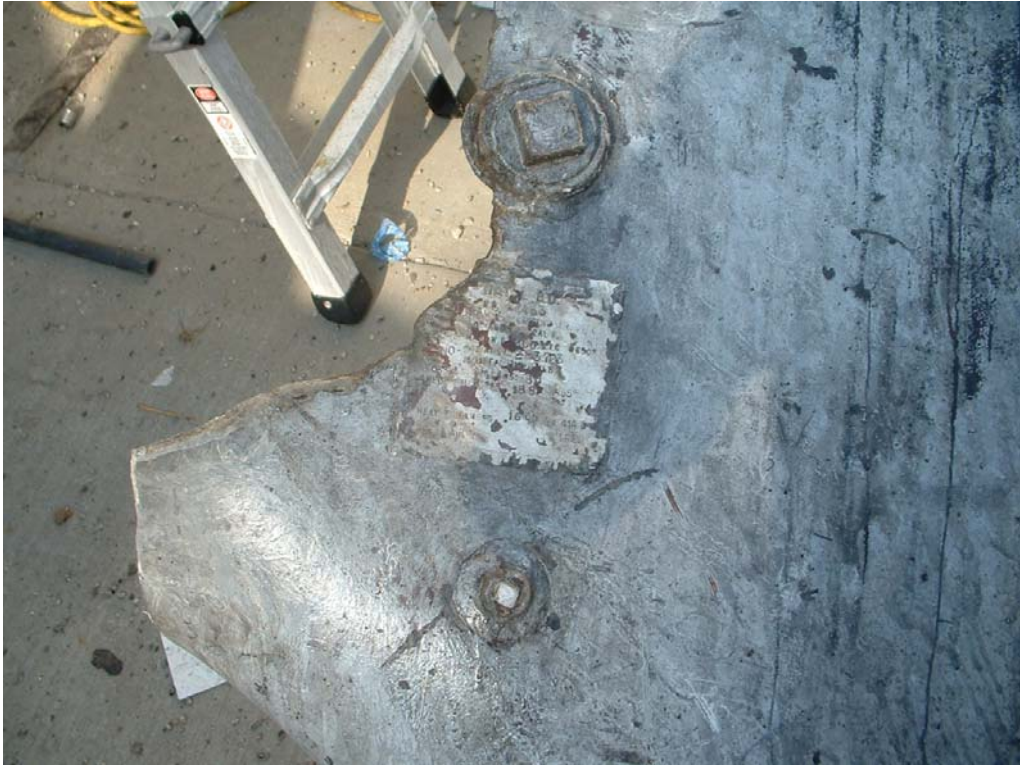
The pressure relief valves from both compressors were tested by the National Board Testing Laboratory and found to be functioning properly. The regulator, safety relief valve, and head of the exploded tank were not found. A visual inspection of the remains of the air tank indicated that corrosion was not a factor. An evaluation performed by an independent failure analysis laboratory, paid for by the insurance carrier for the

compressor manufacturer, found products of combustion in the air tank and a rupture pattern of the tank walls that was consistent with an explosion rather than rupture.

Exhibit 5. A piece of the exploded tank

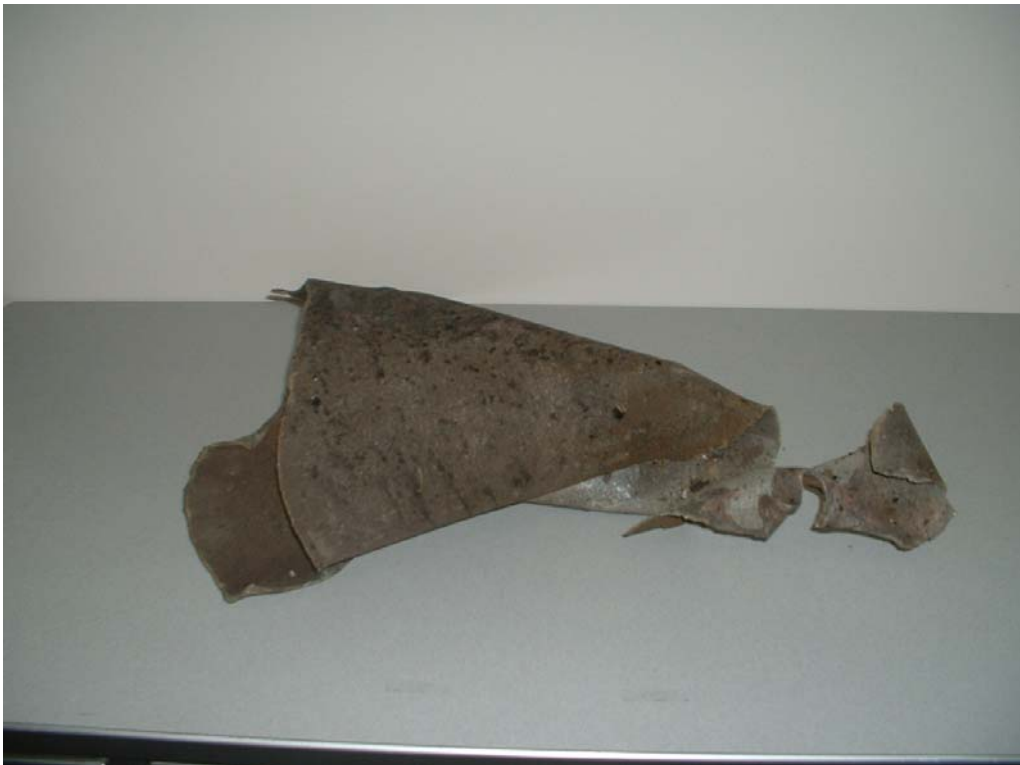
Discussion: The test results of a failure analysis laboratory concluded there were products of combustion in the air tank that were most likely caused by the wrong viscosity of oil being used in the air compressor. The oil in an air compressor serves two purposes. First is to lubricate the compressor as it operates and second, to help cool the compressor and the compressed air it produces. The oil must be of a certain type and viscosity in order to produce the desired results. Manufacturers of air tanks and compressors usually recommended what type of oil to be used in their product. When OEM oil is not used, studies have shown that the oil may leak past the seals and gaskets and form carbon deposits in the supply line. As the diameter of the supply line decreases because of the carbon deposits, the compressed air, which is already at a high temperature, will increase even more, to the point where it might be possible to ignite the carbon deposits. If this should happen, and a piece of ignited carbon gets into the air tank, it could cause an internal explosion. This type of explosion would vary in intensity based on the amount of oil vapor within the tank. Air tank relief valves are not designed for this type of activity, and the air tank could explode, causing severe damage and injury. Although this type of event is rare, it has happened in some businesses and industry throughout the country. The practical prevention measure to take to avoid such an incident is to maintain air compressor equipment in a safe operational condition and to use only the grade of oil recommended by the manufacturer.

Exhibit 6. A piece of the exploded tank showing the inner wall and oily substance

**Recommendation #1: Ensure that air tank and compressors are inspected regularly and maintained in a safe and operational condition, are serviced on a regular basis using OEM (original equipment manufacture) oil, and that all repairs and servicing are documented.**
